# **SHEEP CREEK CANAL (*Carter Creek Portion*) REHABILITATION PROJECT**

## **ENVIRONMENTAL ASSESSMENT**

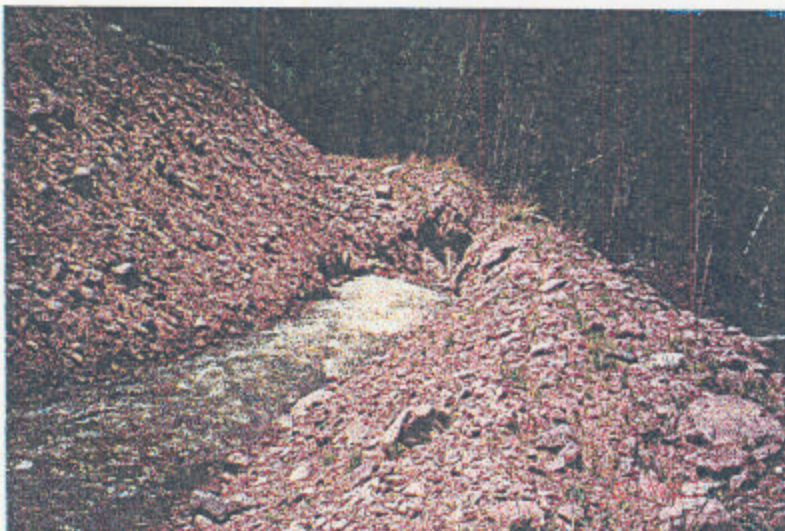
The Carter Creek canal has had a history of past breaches where resource damage to adjacent lands has occurred. The breach shown below occurred in 2000 on the portion of the canal leaving Lily Pad Lake.

**Photo 1 Breach below  
Lily Pad Lake, 2000**

There are two reasons for this. First, the outside berm of the canal is inadequate to contain canal flows (refer to Appendix A). Additionally there are some areas where leaks through the outside berm have led to canal failure.

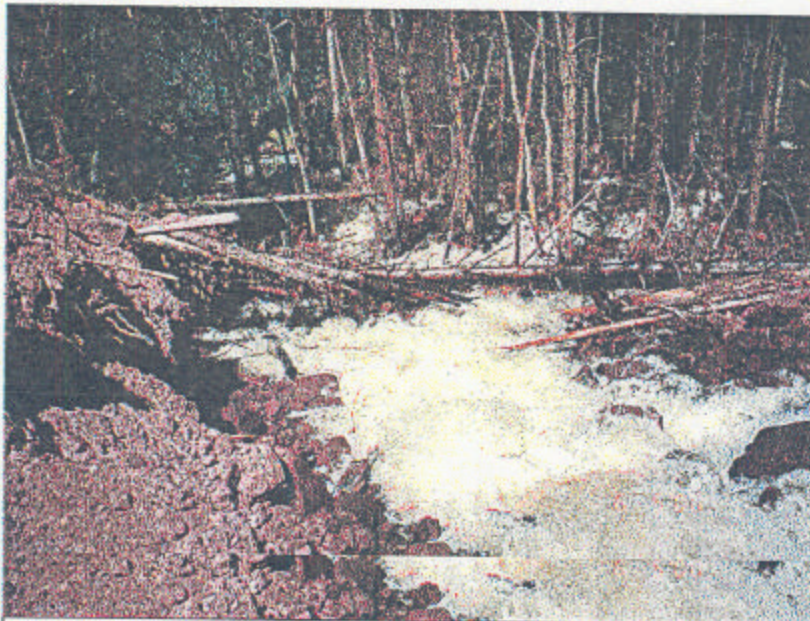
**Photo 2 Resource damage from breach below Lily Pad Lake, 2000**

Where the canal breaches have occurred there have been areas of resource damage. This is shown in the adjacent photo of the Lily Pad Lake canal breach in 2000.

Damage can be extensive with scouring at the breach point, where both the outside berm and the canal itself have eroded away. By rehabilitating the Carter Creek Canal (reconstructing the outside berm to the designs shown in Appendix A), it is expected that the canal would be less likely to breach and the potential for resource damage would be
